The ripple effect comes to Dublin

Quirky detailing and a clever use of poured concrete give this new community centre a dramatic impact

Sean O'Casey Community Centre

Cut-away section through dining area and courtyard

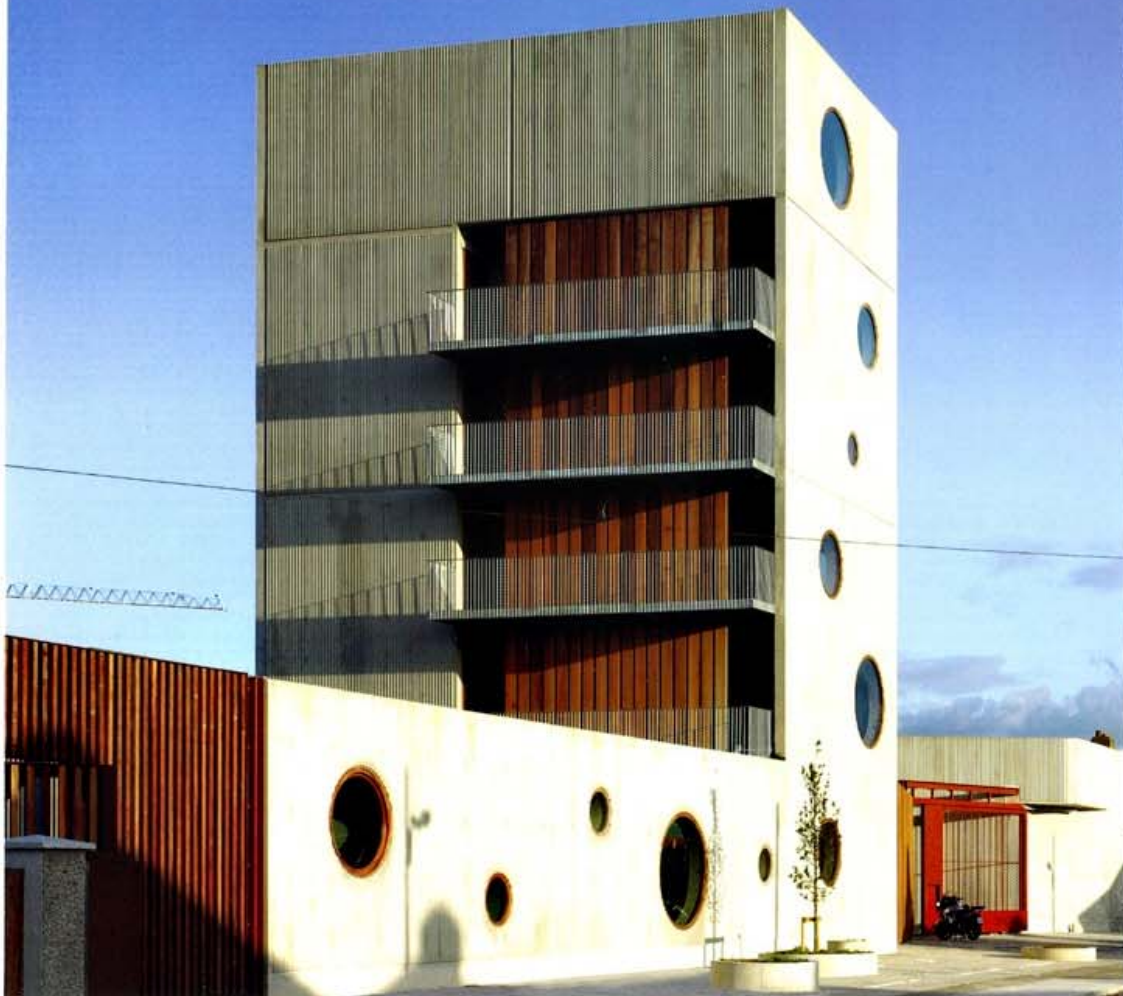
Opposite
The centre's tower rises five storeys above the East Wall neighbourhood.
Above
Reception area with circular rooflights.
Below
Courtyards have been planted with trees that will visually mingle with the vertical mullions.

A five-storey tower rises above the main mass of the building containing classrooms and administration offices. The community groups that make up the client body wanted a large building which would be visible as a symbol of the regeneration of the area. The tower is compact in plan but in the context of the surrounding housing, has a powerful presence reminiscent of the grain silos and warehouses that once characterised the dockland landscape.

The concrete external walls are textured with a ribbed pattern giving the building a robust presence on the street. Three sizes of circular timber window are scattered playfully across the elevations. Small portholes at eye level, middle-size windows at desk level and larger openings at body scale provide welcoming glimpses between the world within and the community outside.

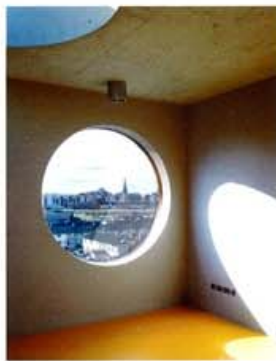
Left
 Circular windows are cut out of the in the exterior concrete walls.

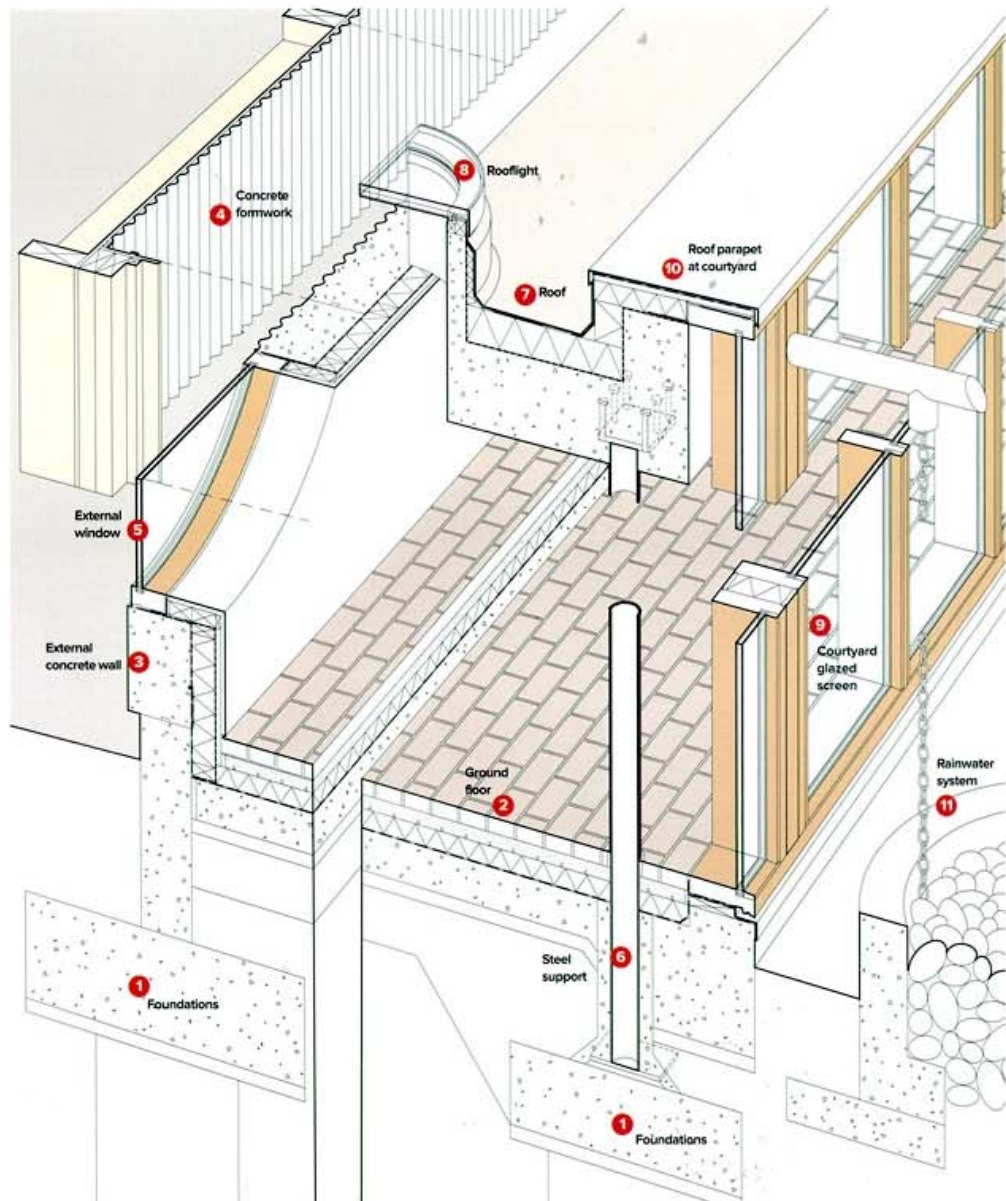
Corrugated concrete walls with circular cut-out windows define the community centre's outer shell. The load-bearing walls were cast in situ using corrugated galvanised steel sheets screwed to the plywood face of the formwork. Circular voids were formed by fixing plywood drums to the formwork. The windows frames are unsealed iroko.

To control shrinkage cracking the walls were poured in a number of sections so one section would have a few days to dry out before the next section was poured. Day joints are concealed in flat strips that also serve to break the walls up into corrugated panels.

The roofs are also cast in situ concrete with the smooth soffit exposed on its underside. The concrete walls and steel supports are built off reinforced concrete strip foundations which bear on compacted stone columns.

Internally the building is arranged around courtyards surrounded by glazed screens. Around the courtyards the roof is supported on steel columns cast directly into the roof slab.

The columns are at close enough centres that the concrete can form a beam between them.

1200 x 400mm reinforced concrete strip footing below external wall on 50mm sand blinding.
 900 x 300mm reinforced concrete strip footing below steel columns on 50mm sand blinding.
 Vibrated stone columns at varying centres.
 Ground floor slab thickness at edges to 400 x 400mm at courtyard perimeter.

55mm brick pavers with two coats clear sealant.
 100mm screed with under-floor heating pipes cast in.
 25mm service void formed between edge of screed and wall using 18mm WBP plywood formwork.
 75mm urethane insulation.
 Damp proof membrane laid over slab and finished 150mm above floor level in cast-in groove in concrete upstand.
 265mm-thick reinforced concrete slab, thickening to 400 x 400mm at courtyard perimeter.
 50mm blinding and 200mm compacted hardcore.

500mm-high x 250mm-wide reinforced concrete kicker with hydrophilic strip on top.
 300mm-thick reinforced concrete wall cast in situ with corrugated surface and class C finish externally.
 Internal breather membrane

bonded to DPM base.
 100 x 75mm softwood studs at 400mm centres.
 100mm high density insulation between studs.
 Vapour barrier.
 75 x 25mm softwood battens forming 25mm service void.
 15mm skimmed plasterboard internal lining with painted finish.

1220 x 3810 x 0.4mm corrugated galvanised steel sheets nailed to plywood and holes sealed.
 Sheets overlapped by 1/2 corrugations.

Ex 150 x 75mm iroko window frame screwed to concrete via galvanised steel angle brackets.
 Bituminous DPC fixed to frame, dressed over internal breather membrane and bonded to concrete.
 Breathable mastic seal.
 15mm skimmed plasterboard internal lining fixed to 50mm softwood studwork to form window reveal.

114 x 6mm galvanised steel CHS columns at 2.5m centres to courtyard.
 275 x 275 x 15mm baseplate welded to CHS and bolted to concrete footing.
 Column cased in 50mm mass concrete up to slab

level as corrosion protection.
 400 x 200 x 20mm thick steel plate welded to top of CHS and cast into roof slab 75mm above underside.
 Ten 19mm diameter x 120mm high shear studs welded to top side of plate to tie column head into reinforcement of slab.

Two-layer polymer modified bitumen waterproof membrane with mineral chips on exposed surfaces.
 Tapered polyisocyanurate insulation varying from 110 to 270mm thick to form 1.80 fall.
 12mm foil vapour barrier.
 300mm fair-faced reinforced concrete roof slab left exposed internally with Class C patterned finish.
 Plywood formwork with joints and fixings set out to correspond with plan.

375mm-high x 75mm-wide reinforced concrete upstand.
 25mm PIR insulation around upstand.
 75 x 50mm softwood kerb screwed to upstand.
 Top layer of polymer modified bitumen waterproof membrane dressed up upstand and under rooflight frame.
 700 / 1400 or 2100mm diameter circular extruded aluminium frame screwed to kerb to ensure 1:100 fall.
 Walk-on double glazed

sealed unit consisting of 21.5mm toughened laminated outer pane, 16mm air filled cavity, 6mm soft coat low-E inner pane.

250 x 75mm iroko mullions, head and cill members.
 Double glazed sealed units.

250mm wide x 260mm high reinforced concrete upstand.
 Glazed screen head member restrained back to upstand with galvanised steel angle bolted to concrete.
 Vapour barrier.
 DPM fixed to top of glazing frame.

44 x 80mm (tapering to 70mm) treated softwood battens fixed to upstand.
 18mm WBP plywood fixed to battens and glazing frame.
 Top layer of polymer modified bitumen waterproof membrane dressed up and over plywood.
 3mm galvanised steel coping fixed to plywood.
 100mm diameter x 1m long stainless-steel pipe between paired mullions.
 Stainless-steel chain fixed through hole in bottom of pipe to take water to ground.
 900mm diameter reinforced concrete ring supported on 500 x 150mm reinforced concrete footing.

The external walls, upper floors and roofs are all concrete, cast in situ (see detail, page 8). To form the ribbed pattern the contractor initially proposed a German proprietary form liner system, but this was proving uneconomical for the limited number of pours required. As a cheaper alternative, corrugated galvanised steel sheets from the local builder's merchant were tried, fixed to the inside of standard plywood shutters. With a bit of practice these

were found to give excellent results and were easy to adapt on site. The tricky thing with the sinusoidal shape was to seal all the edges. Adjacent sheets were lapped by 1/2 corrugations and compressible seals were used at the edges.

Achieving the carefully proportioned elevation patterns involved close coordination of day-joints between the architects and structural engineer Casey O'Rourke. Ideally the pour sizes needed to be small to avoid shrinkage cracking without the need for excessive reinforcement. The walls and parapet were therefore cast in full-height sections so that the only horizontal joint is at the bottom between the plinth and wall. Proprietary starter bars were cast into the walls to support the roof and intermediate floors of the tower.

Day joints were difficult to form neatly in the corrugated formwork so flat sections were introduced that could be rubbed down once the formwork was struck. These recesses introduce another layer of proportion to the facades and give the ribbed areas a more crafted feel. Internally the same attention was given to the exposed concrete soffits. The joints were all set out and the surface was rubbed by hand once the phenolic-faced birch plywood formwork was removed.
